SITE REMEDIATION FORMER MINING SITE

Association of the owners of the former Quebec Copper Mines (Bolton, Eastern Townships).

Permanent remediation of the mine tailings area. The Quebec Copper mine closed in 1957.

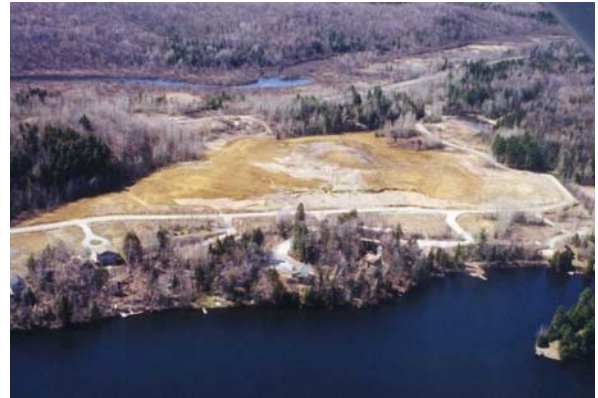
Aerial view before remediation

- 6 ha surface of mine tailings, light generator of acid mine drainage
- Near residences, water sources, and a lake
- Problems of wind and water erosion
- Excessive sedimentation in ditches and water sources
- Unable to establish a permanent vegetation cover

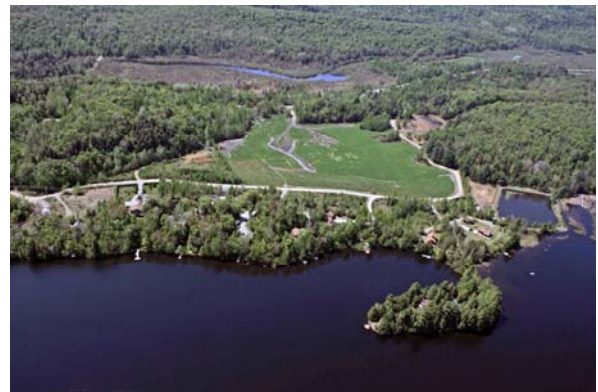
Aerial view after remediation

- Drastic reduction of environmental problems related to erosion and acidic leachate
- Significant improvement of the site's aesthetic
- Remediation costs reduced due to use of de-inking residues and other residual matters
- Enhancement of the site's value

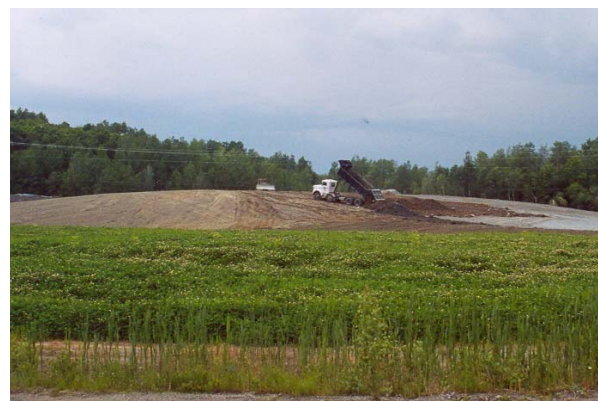
A layer of earth is placed over the low permeability membrane

- Agreement between the owners and GSI Environment
- Characterization of mining residues
- Obtaining the authorizations required by the municipality and the ministère du Développement durable, de l'Environnement et des Parcs (MDDEP)
- Neutralization of the mining residues at the surface (25 cm) by adding liming agents
- Installation of a 70 to 100 cm thick impervious membrane containing de-inking residues from paper recycling
- Addition of a 30 to 40 cm layer of soil (sand and/or silt) to cover the low permeability membrane
- Amendment of the soil layer by using compost made of bark and municipal biosolids
- Year 1: Herbaceous species seeds spread
- Year 2: Forest species planted
